Analysis of Gas Pipeline Failure

By E. Phillip Dahlberg and T.V. Bruno, Element Houston, 222 Cavalcade Street, Houston, Texas 77009

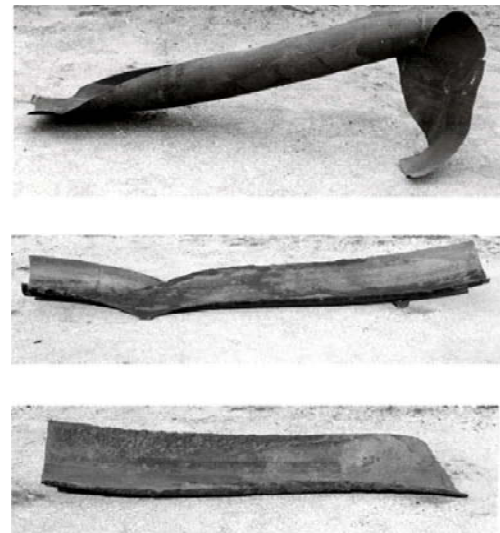
Figure 2. Rupture sections of 8-5/8 inch gas pipeline that failed due to external mechanical damage.

Figure 2 shows the rupture that developed in a section of 8-5/8 inch O.D. electric resistance line pipe. Visual and metallographic examination revealed the failure was caused by mechanical damage, in the form of a gouge and dent, often associated with heavy equipment such as a back-hoe. Figure 3 shows a detail of a gouge that was near the midpoint of the rupture. The profile of the gouge, shown in Figure 4, is a polished and etched cross section of matching fracture surfaces at the failure origin. The combination of a gouge and dent is particularly damaging. The gouge cold works the steel and reduces its resistance to crack initiation. The dent, by changing the geometry, creates an area of high stress and stress concentration.

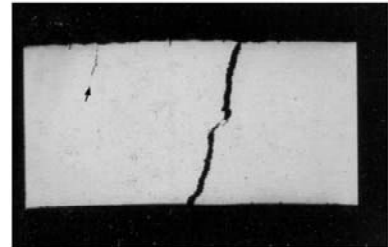
Figure 3. A 3-1/2 inch long gouge found near the midpoint of the rupture shown in Figure 2.

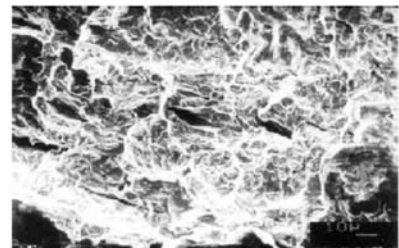
Figure 4. A cross section through the gouge Shows a dark etching area near the outside Surface with a small secondary crack (arrow) Near the fracture.

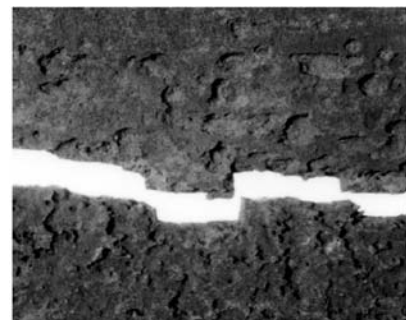
Figure 5. SEM fractograph of fatigue damage associated with the longitudinal weld seam of a 34-inch O.D. pipeline.

A second form of external damage can be introduced by fatigue cracking during pipe shipment, particularly in rail and sea shipment. The damage, sometimes called transit fatigue, results from flexing the pipe during load movement. Transit fatigue in seamless pipe and the base metal of welded pipe results from concentrated stresses where the pipe contacts a protrusion, such as a rivet or bolt, the weld of an adjacent pipe, or bearing strips of insufficient size. In submerged-arc welded pipe, transit fatigue cracks can develop at the toe of the weld even in the absence point contact. Figure 5 shows the fine ductile fatigue striations and secondary cracking that characterize transit fatigue damage.

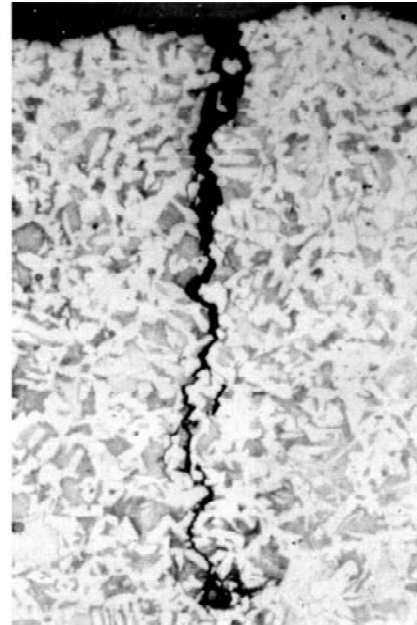
Figure 10. Microstructure in area of secondary crack showing an intergranular cracking mode.

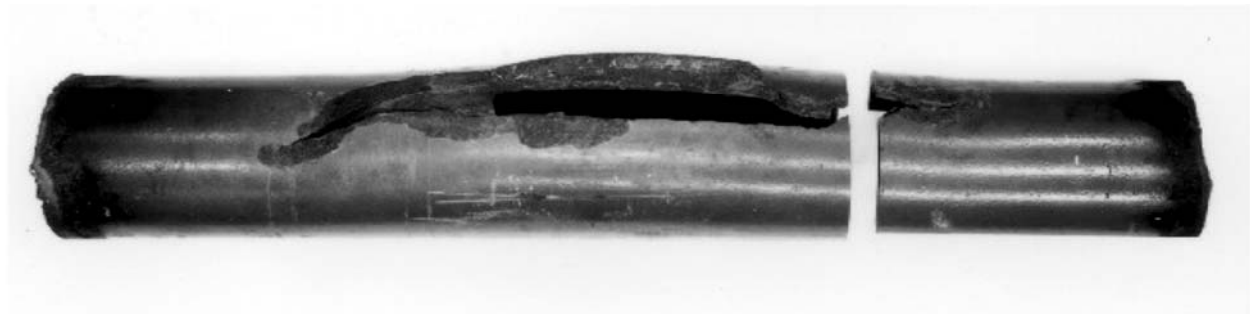
Material defects are not common causes of service failures because they are usually found before the pipe is placed in service, either during inspection of the pipe or during hydrostatic testing. The few failures that do result typically originate at longitudinal weld seams or at laminations in seamless pipe. Figure 11 shows the rupture of a 6-5/8 inch O.D. seamless pipeline that resulted from a pipe lamination. In this instance, failure occurred during hydrostatic testing.

Figure 11. Hydrostatic test rupture of seamless 6-5/8 inch O.D. pipeline showing thin tongue of metal protruding from around a pipe lamination.
