Analysis of Gas Pipeline Failure

By E. Phillip Dahlberg and T.V. Bruno, Element Houston, 222 Cavalcade Street, Houston, Texas 77009

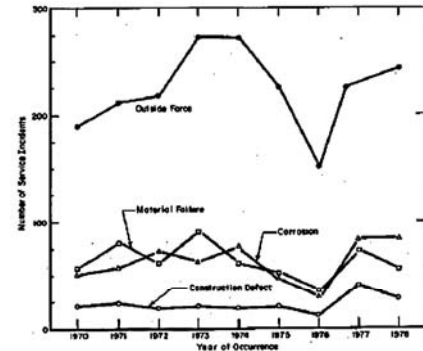
Figure 1. Number of gas pipeline service incidents versus year of occurrence by cause. (From Giedon, D.N. and R.B. Smith, "An Analysis of Reportable Incidents for Natural Gas Transmission and Gathering Lines 1970 through 1978," NG-18 Report No. 121, Sept. 1980.)

Over half of all in-service pipeline failures result from some externally applied mechanical force as shown in Figure 1. The following are examples of five typical failures.
